Analysis of Cold In-place Recycled Asphalt Pavements

A research study by Organizational Results in cooperation with the Northwest District and the Maintenance Division

MoDOT Summary Statement

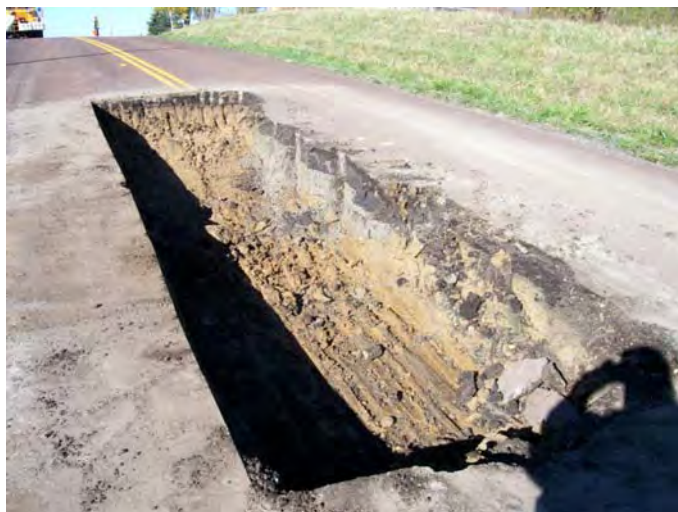
Figure 2 – Maintenance repairs

The CIR project in Gentry Co. has been open to the traffic for more than one year. Immediately after construction, the comments from the traveling public were quite favorable. However, within five weeks after the routes were opened to traffic, the first of many failures in the road surface began to appear. Areas of fatigue cracking were first noticed before the surface began to break up and the underlying subgrade worked its way to the surface. The subgrade turned out to be wet clay.

Maintenance crews tried to repair these failures by removing the failed area down to a depth of approximately two feet (*Figure 2*). Once the wet clay subgrade was removed, crushed limestone was placed in the hole and compacted before a cold-mix asphalt patch was placed. The early failures were sporadic at first, but became more numerous as time passed. All of the failed areas were outside of the test sections that were set up prior to construction.

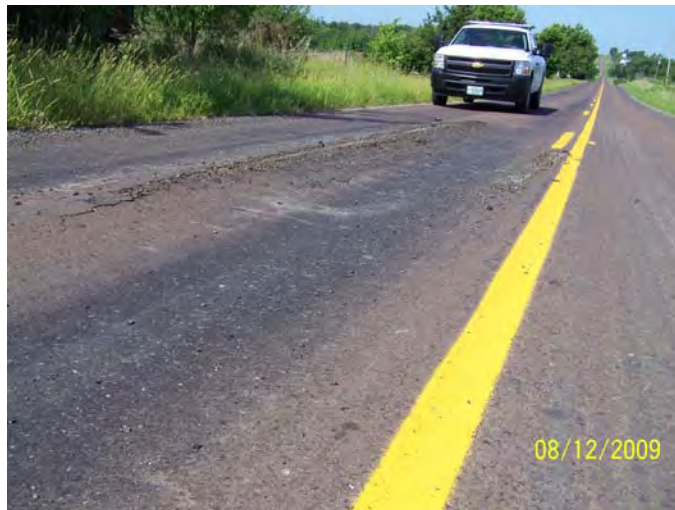
Figure 3 – Pavement rutting

The rutting and fatigue cracking that was so prevalent throughout the test sections prior to construction were eliminated with the CIR placement. After 6 months of service, there was no evidence of rutting in any of the test sections and only a small amount of low severity fatigue cracking was found. Rutting in the test sections did appear during the one-year survey and was

almost identical to the severity that was recorded prior to construction. The fatigue cracking wasn't as severe as it was prior to construction, but the areas of fatigue cracking did increase dramatically when compared to the six-month visual distress survey.

As the patching and repairs became more frequent during the summer months, it was decided that a 1-1/4" hot mix overlay should be placed on the CIR. The overlay was placed in October 2009.
